EISENHOWER ELEMENTARY SCHOOL

Outlet Sampling and Plumbing Assessment Recommendations

1235 Pershing Street, Flint, Michigan 48503

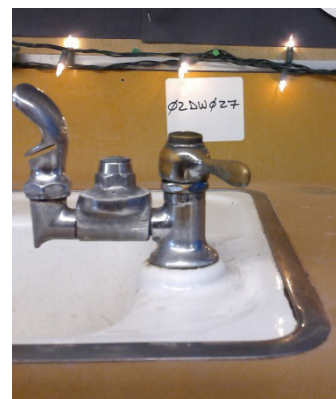
Outlet: Bubbler Fountain (02DW027)

Location: Classroom 204, southwest wall

Results: P1=18 parts per billion, P2=8 parts per billion

F01=2 parts per billion, F02=1 part per billion

These results suggest the highest contribution of lead may be from the bubbler and its connecting plumbing. This bubbler fixture is made of chrome plated brass and has a brass connector on the underside of the sink. The bubbler also has a chrome plated brass flow regulator installed between the operating valve and the outlet. The connecting plumbing is copper with lead solder and includes a brass shut off valve.

Replacement of this bubbler tap and its connection plumbing with lead free materials will significantly reduce lead exposure at this location. If replacement is not currently feasible, sample results indicate that flushing this tap for 3 minutes following periods of stagnation is likely to reduce lead concentrations and lead exposure.

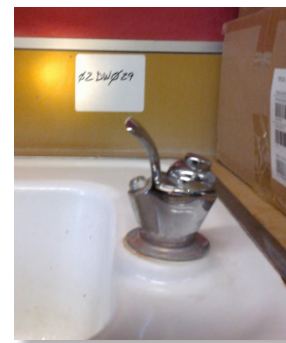
Outlet: Bubbler Fountain (02DW029)

Location: Classroom 205, northeast wall

Results: P1=39 parts per billion, P2=14 parts per billion

F01=11 parts per billion, F02=1 part per billion

These results suggest the highest contribution of lead may be from the bubbler and its connecting plumbing. This bubbler fixture is made of chrome plated brass and has a brass connector on the underside of the sink. Connecting plumbing in the cabinet under the sink is made up of brass connectors and copper piping with lead solder.

Replacement of this bubbler tap and its connection plumbing with lead free materials will significantly reduce lead exposure at this location. If replacement is not currently feasible, sample results indicate that flushing this tap for 3 minutes following periods of stagnation is likely to reduce lead concentrations and lead exposure.

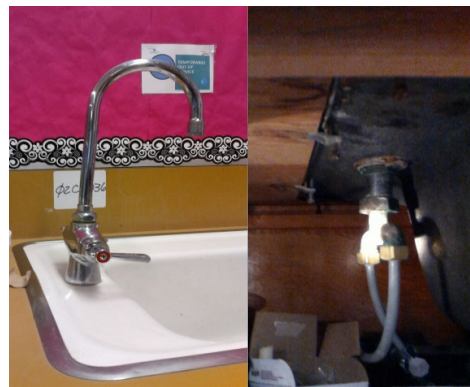
Outlet: Sink Faucet (02CF036)

Location: Classroom 209, southwest wall

Results: P1=7 parts per billion, P2=21 parts per billion

F01=5 parts per billion, F02=1 part per billion

These results suggest the highest contribution of lead may be from the faucet and its connecting plumbing. The base of this faucet is chrome plated brass, and has a brass connection on the underside of the sink. Hot and cold water lines connect to this faucet with a brass mixer fitting under the sink. Connecting plumbing in the cabinet under the sink may also contain additional brass connectors and copper plumbing with lead solder.

Replacement of this faucet and its connection plumbing with lead free materials will significantly reduce lead exposure at this location. If replacement is not currently feasible, sample results indicate that flushing this tap for 3 minutes following periods of stagnation is likely to reduce lead concentrations and lead exposure.

This faucet also has an aerator/screen at the outlet. If the faucet is not replaced, the aerator/screen should be removed, inspected for particulate accumulations, scrubbed clean, and reinstalled. If particulates are found, the aerator/screen should be periodically checked and cleaned.

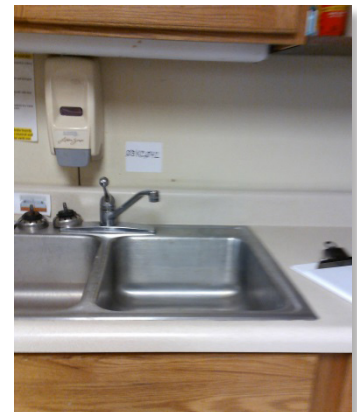
Outlet: Kitchen Faucet, Left (03KC041)

Location: Outbuilding Unit 1, Proposed Preschool

Results: P1=0.33 parts per million, P2=1.84 parts per million
F01=1.07 parts per million, F02=1.12 parts per million

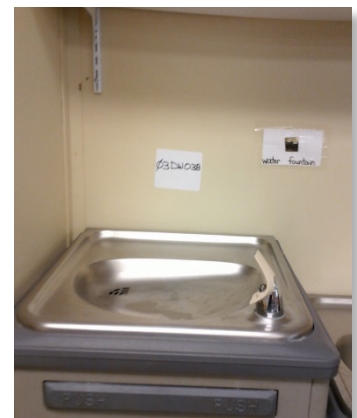
Outlet: Water Cooler, Left (03DW038)

Location: Outbuilding Unit 1, Proposed Preschool

Results: P1=2.77 parts per million, P2=1.37 parts per million
F01=1.2 parts per million, F02=1.03 parts per million
